MICROCHIP PIC18F2420/2520/4420/4520

PIC18F2420/2520/4420/4520 Rev. A1 Silicon Errata Sheet

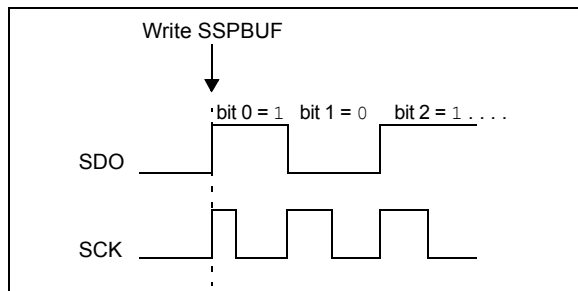
FIGURE 1: SCK PULSE VARIATION USING TIMER2/2

When the SPI is using Timer2/2 as the clock source, a shorter than expected SCK pulse may occur on the first bit of the transmitted/received data (Figure 1).

To avoid producing the short pulse, turn off Timer2 and clear the TMR2 register, load the SSPBUF with the data to transmit and then turn Timer2 back on. Refer to Example 4 for sample code.
